A Temperature Study of Pneumatic Tires During Highway Operation

TECHNICAL REPORT NO. 11716

by DAVID K. WILBURN

U.S. ARMY TANK AUTOMOTIVE COMMAND Warren, Michigan

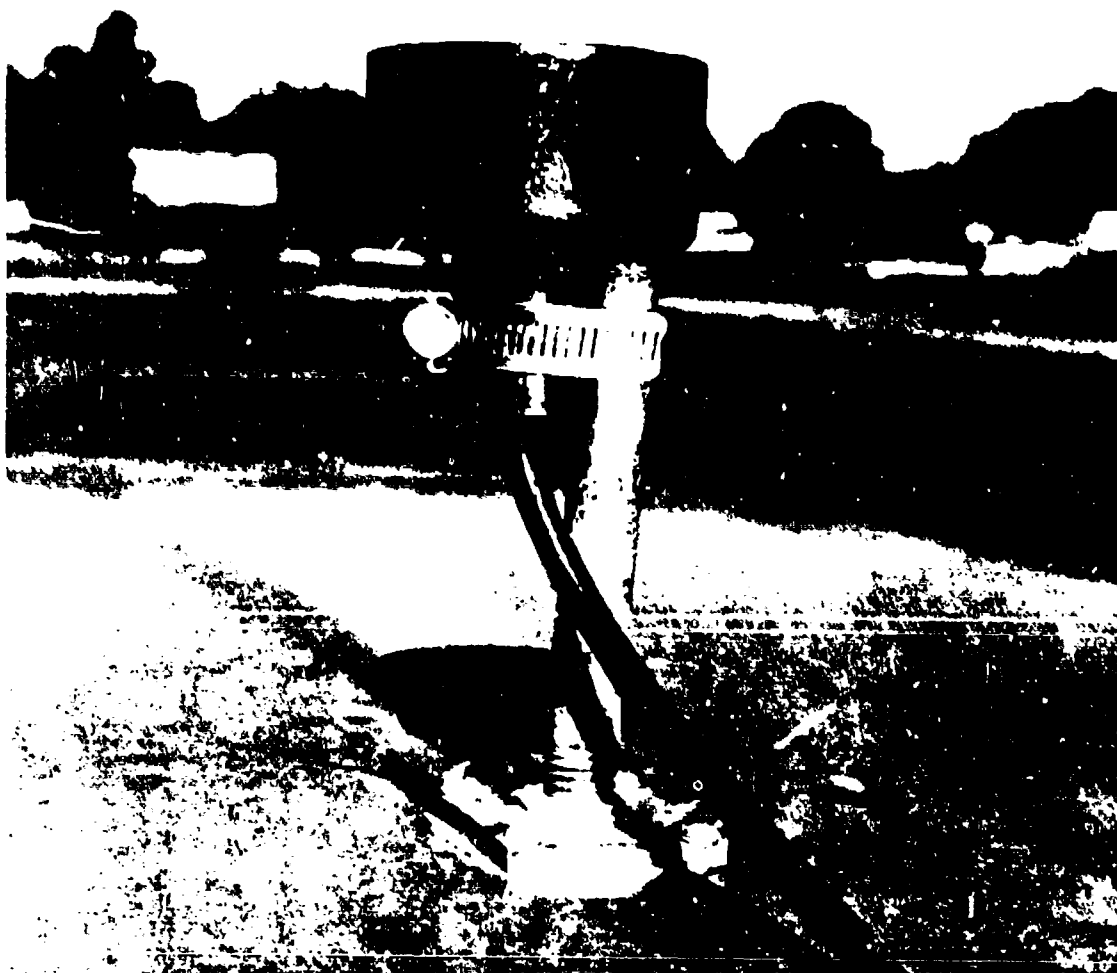
FIGURE 4

PYRANOMETER PHOTOCELL MOUNTED
ON ROOF OF TEST VEHICLE

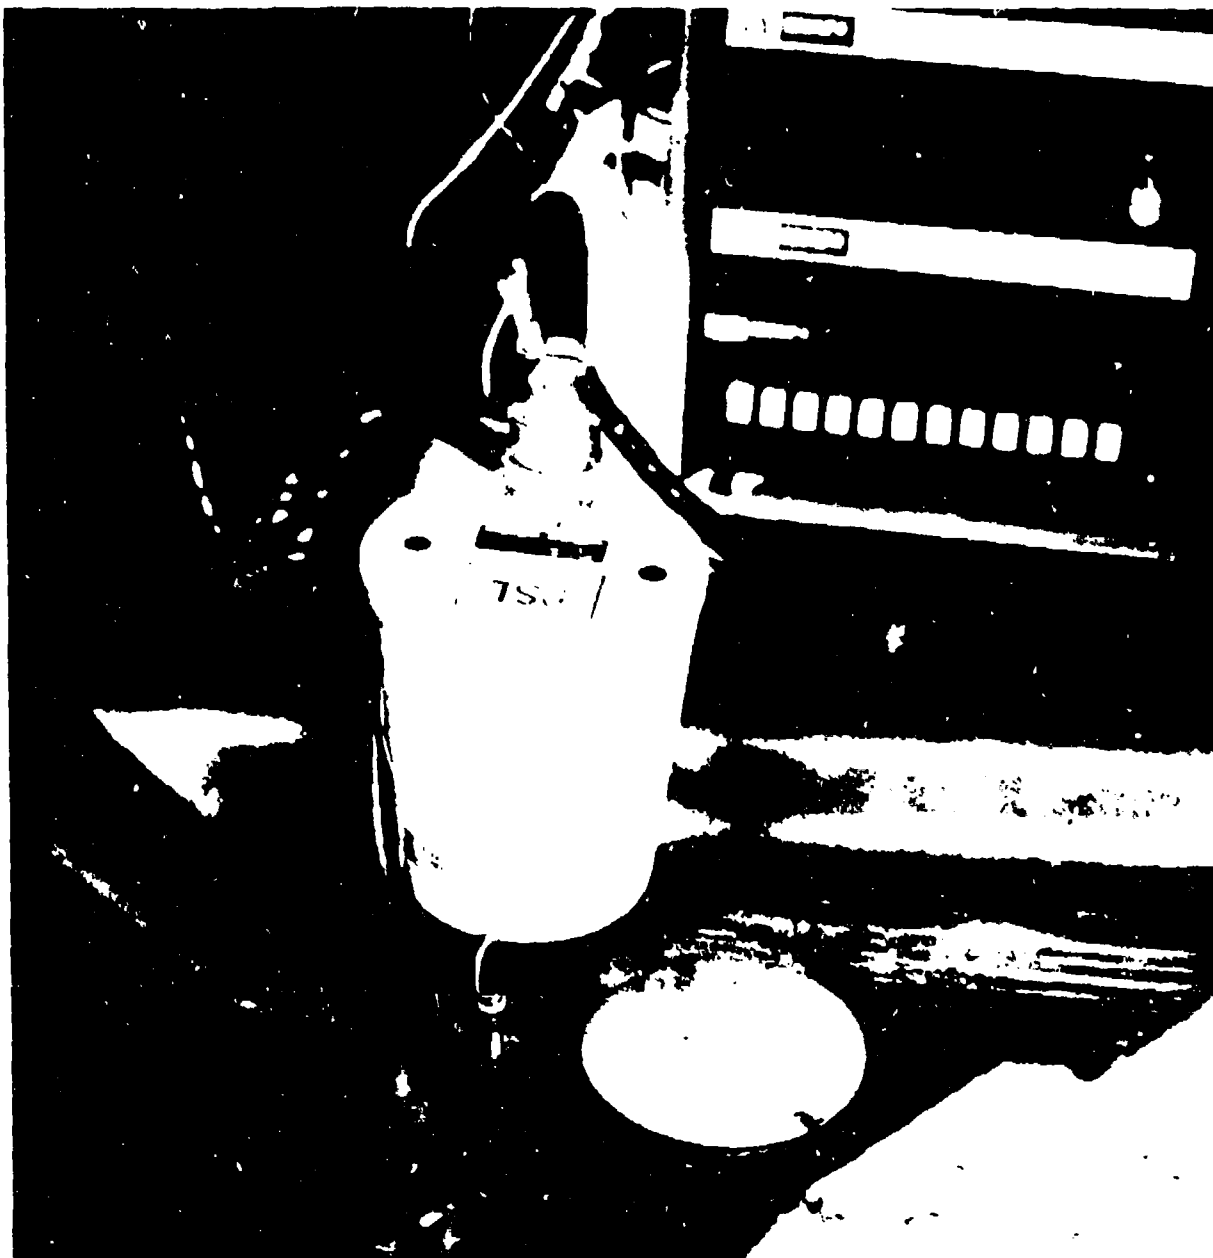
FIGURE 5

INFRARED THERMOMETER POSITIONED TO VIEW
ROAD SURFACE

The pyranometer cell is shown mounted in the roof of the car in Figure 3. To monitor road surface temperature, an infrared thermometer was mounted vertically to view the road surface thru a hole cut in the rear floor panel.

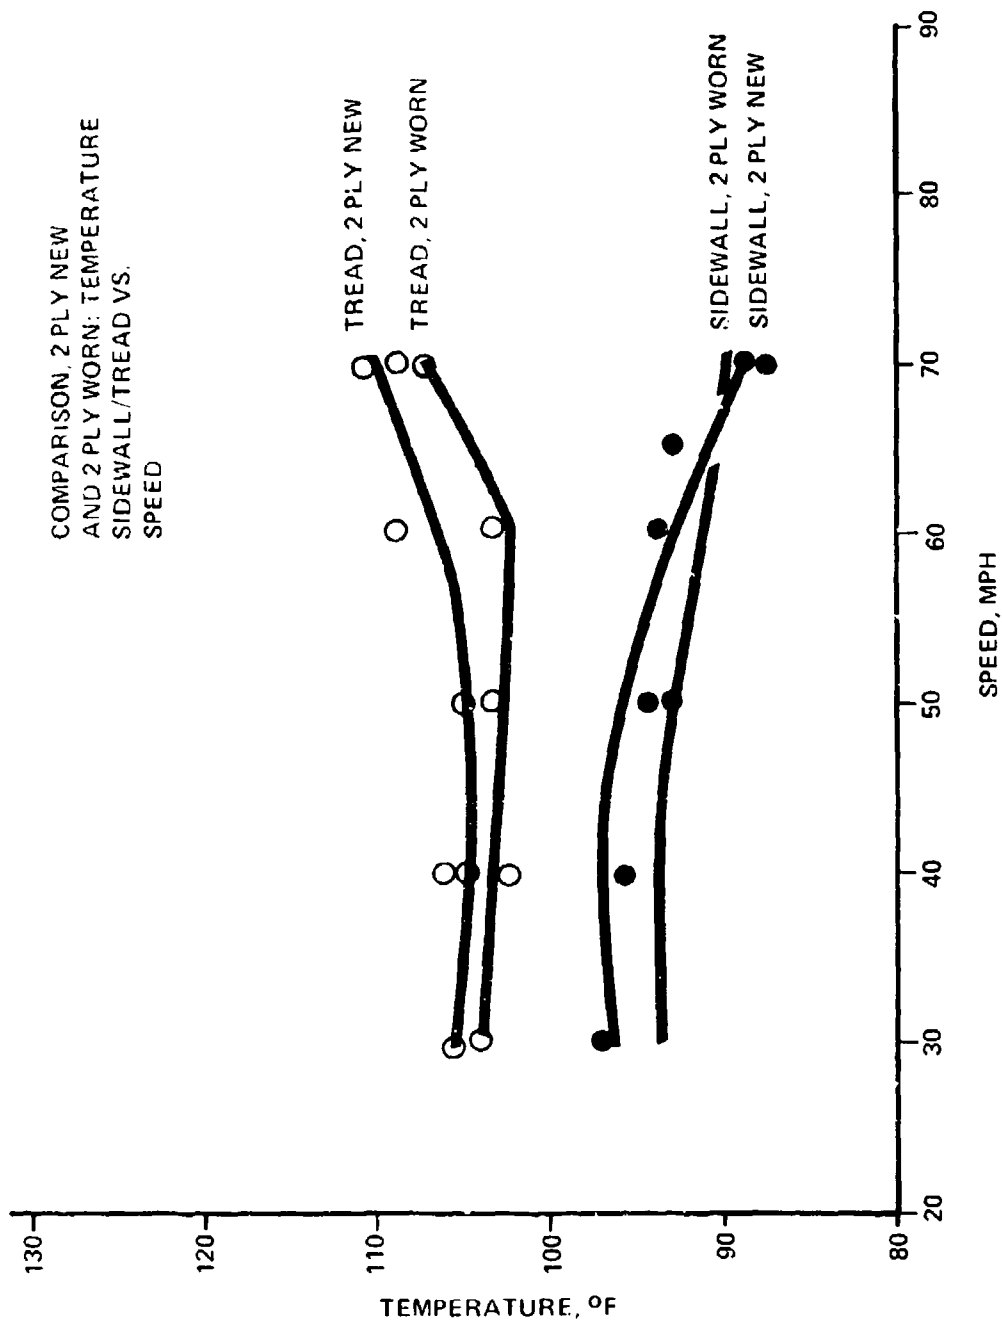
FIGURE 12

- 12 COMPARISON, 2-PLY WORN TO 1/16 TREAD DEPTH. TEMPERA-
 TURE SIDEWALL AND TREAD VERSUS SPEED. TEST TIRES
 # 4 & 1
- 13 SPEED VERSUS TEMPERATURE OF SIDEWALL FOR VARIOUS
 ROAD TEMPERATURES. TEST TIRE # 8

A comparison was also made between operating temperatures of 2-ply and 4-ply tires and new tread and worn (1.8 inch depth) tires (Figures 11 and 12). In general, 2 ply tires run cooler than 4 ply, and worn tires run cooler than new tread tires.

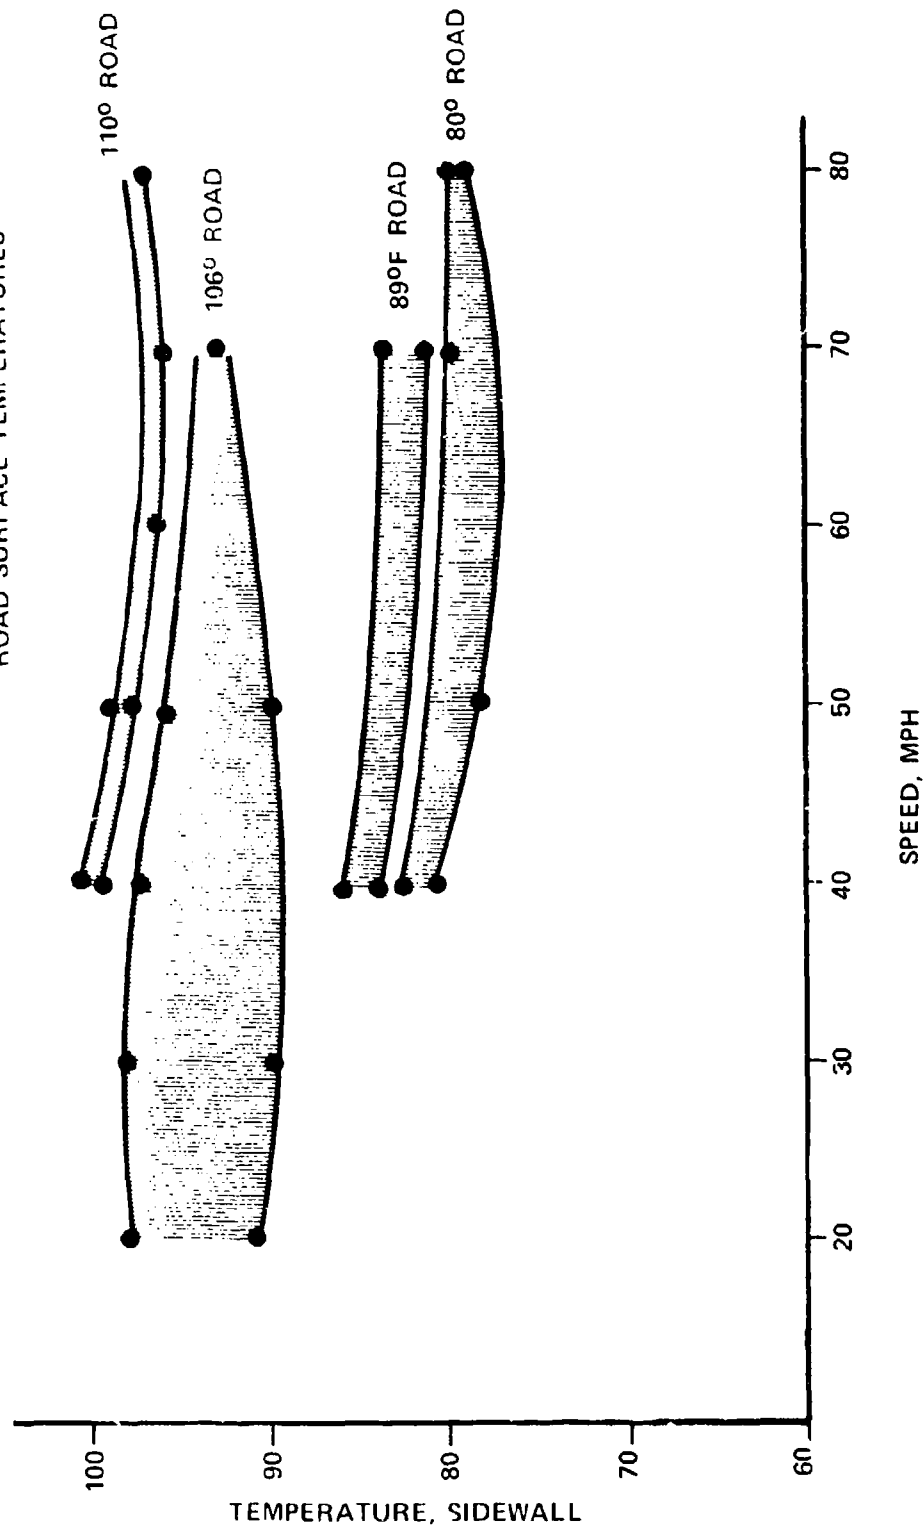
FIGURE 13

SPEED VS TEMPERATURE
SIDEWALL FOR VARIOUS
ROAD SURFACE TEMPERATURES

Effects of inflation, load and speed also can work in combination. As speed increases and road temperature increases, Figure 13 illustrates a corresponding increase in sidewall temperature. Since speed affects tread temperature more than sidewall, Figure 15 shows the effects of speed on tread for reduced inflation pressures. This indicates that low inflation pressure produces elevated tread temperatures as speed increases, especially as compared to a normal inflation pressure which shows little change in tread temperature with increase in speed. Figure 16 shows the same conditions of inflation and speed for the sidewall.

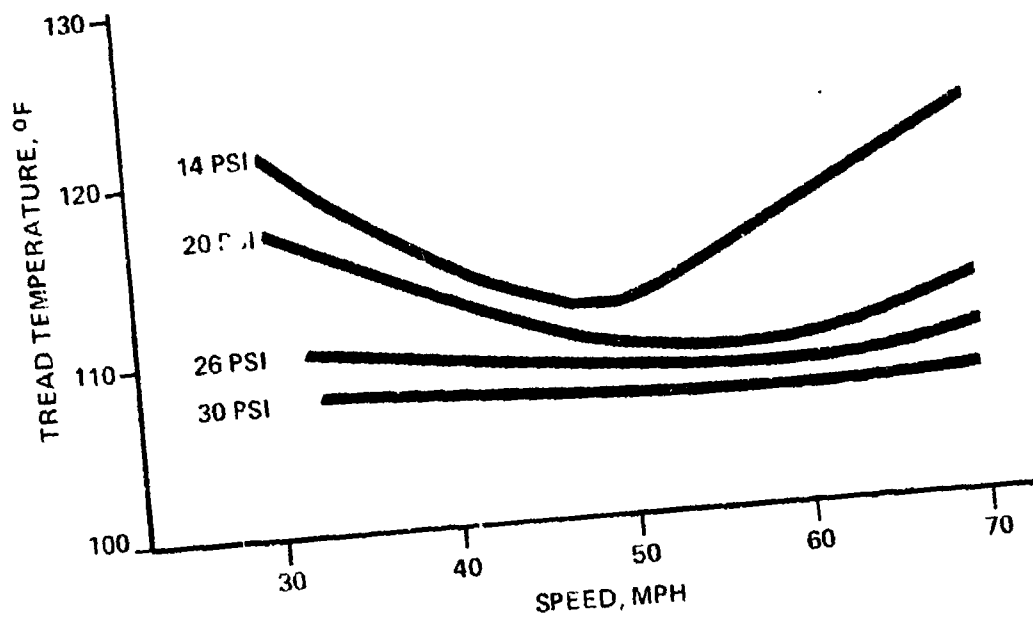
FIGURE 15

TREAD TEMPERATURE VS. SPEED
FOR TIRE PRESSURES OF
14, 20, 26 & 30 PSI

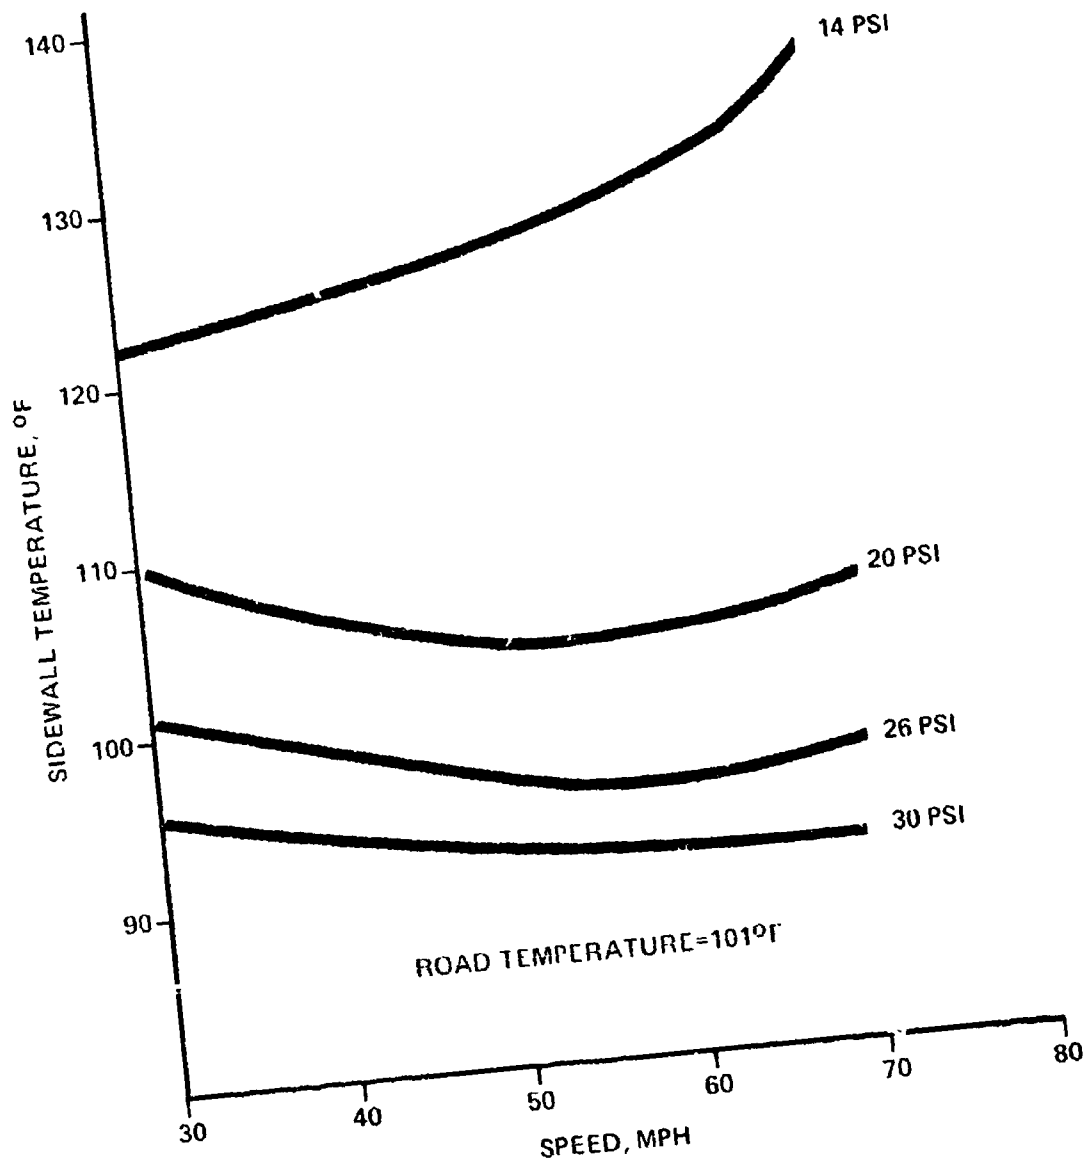
FIGURE 16

SIDEWALL TEMPERATURE VS.
SPEED FOR TIRE INFLATION PRESSURES
OF 14, 20, 26 & 30 PSI

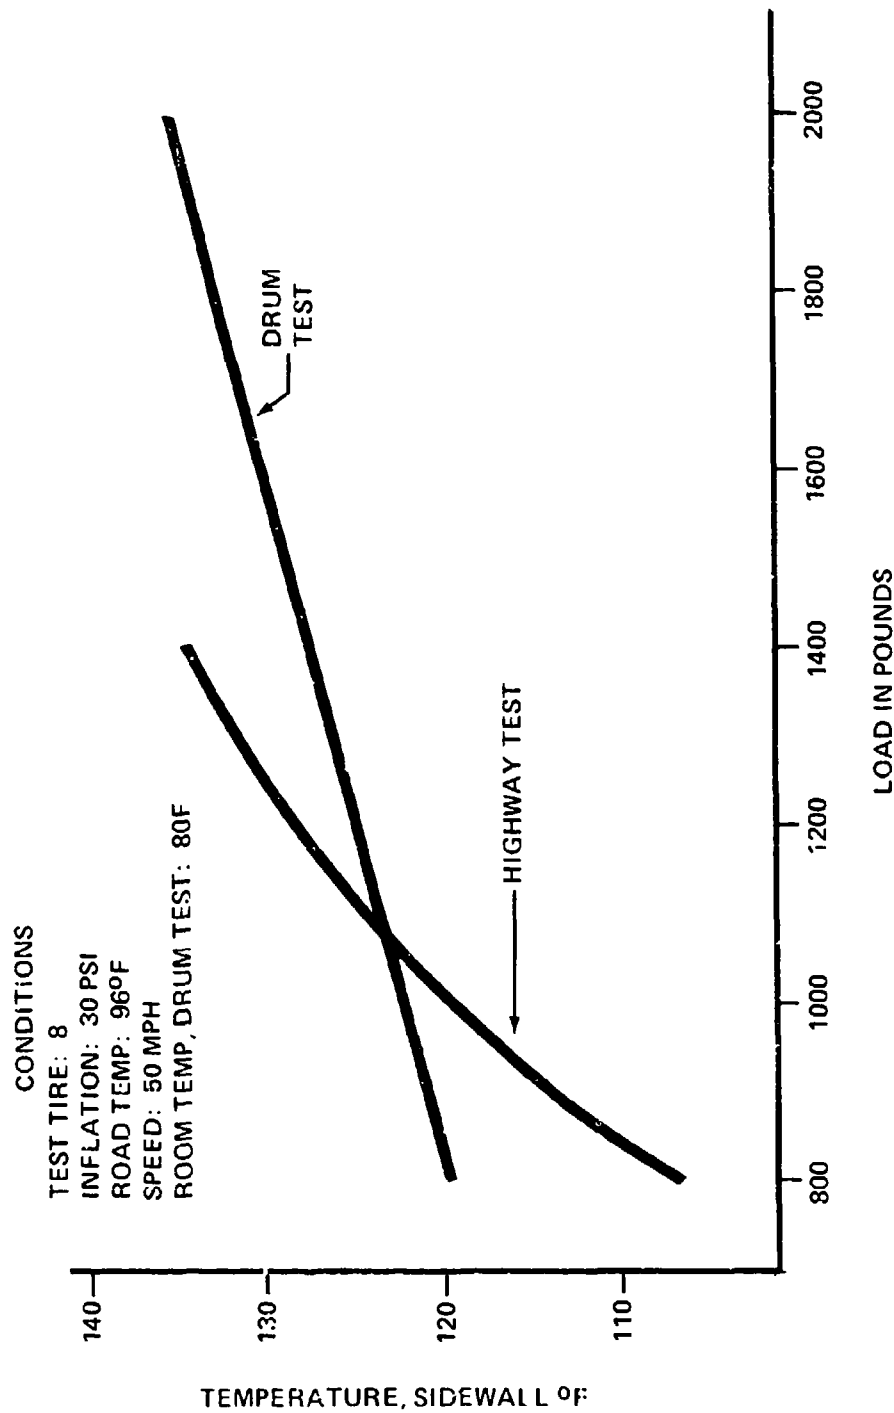
FIGURE 19

| 19 | COMPARISON; LOAD ON TIRE VERSUS TEMPERATURE OF SIDEWALL FOR DRUM TEST AND HIGHWAY CONDITIONS |

COMPARISON: LOAD ON TIRE VS.
TEMPERATURE OF SIDEWALL
FOR DRUM TEST & HIGHWAY

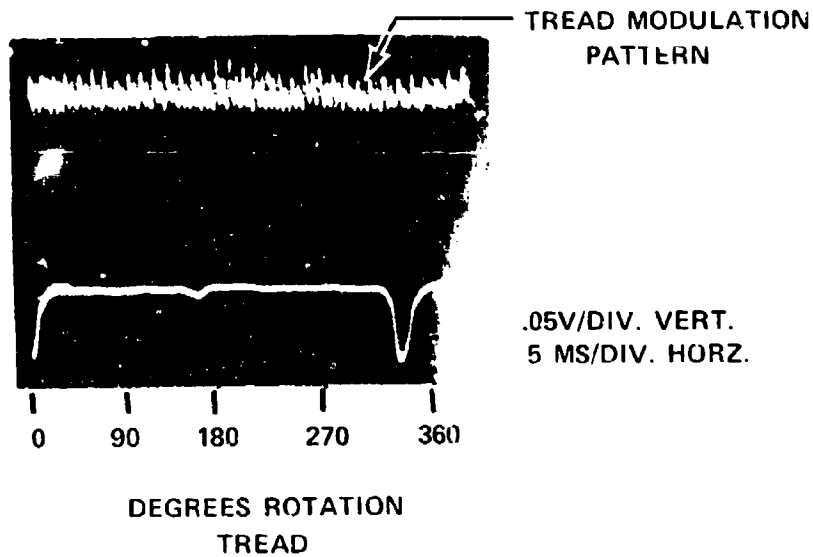
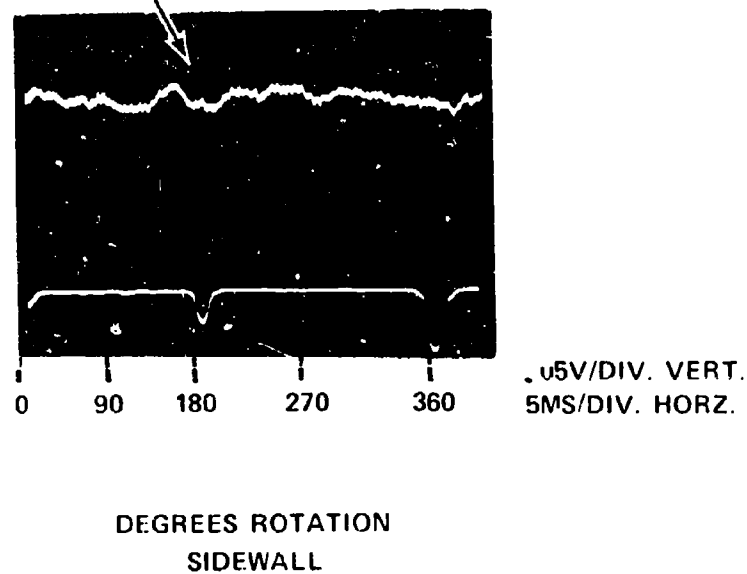
FIGURE 20

| 20 | CIRCUMFERENTIAL TEMPERATURE PROFILE OF TREAD AND LEFT SIDEWALL; TEST TIRE NO. 6 WITH BUILT IN DEFECT* |

- * Ply separation in shoulder opposite serial placed on either side of tread splice produced by 1/2 x 1/2 inch piece of diaphragm stock.
- ** Ply separation in shoulder opposite serial placed on either side of tread splice produced by 1/2 x 1/2 inch piece of aluminum metal foil.

CIRCUMFERTIAL TEMPERATURE
PROFILE, TEST TIRE NO. 6

TEST CONDITIONS

50 MPH
1000 LOAD
32 PSI
CEMENT
ROAD=105°F
AIR=80°F

DEFECT AREA

Voltage of Signal Produced by Defect	Millisecond Width of Defect Pulse
Test Tire # 6	+0.2	3
Test Tire # 5	-0.4	2

The thermal modulation effect produced by the tread pattern in military tires and reported on in reference 1 was not observed in the highway tires. Test tire # 6 having a "high traction tread" produced a slight modulation of the circumferential temperature profile as seen in Figure 20, but did not disturb the normal tread profile.

The circumferential profiles of Figure 20 thru 22 were not calibrated in terms of "temperature of defect". This type of calibration is possible but was not warranted for purposes of this test. As indicated in Table V, the defect area was described in terms of a voltage differential between the signal generated by the defect and adjacent "sound" surface.

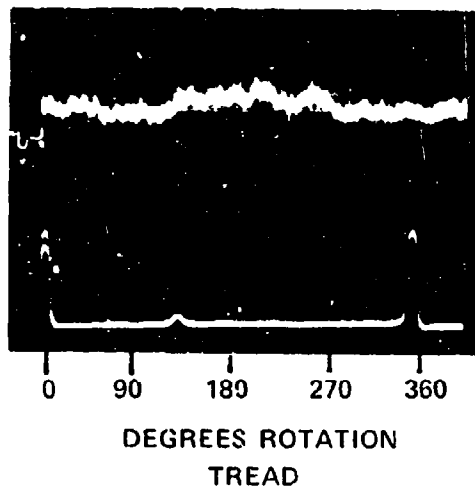
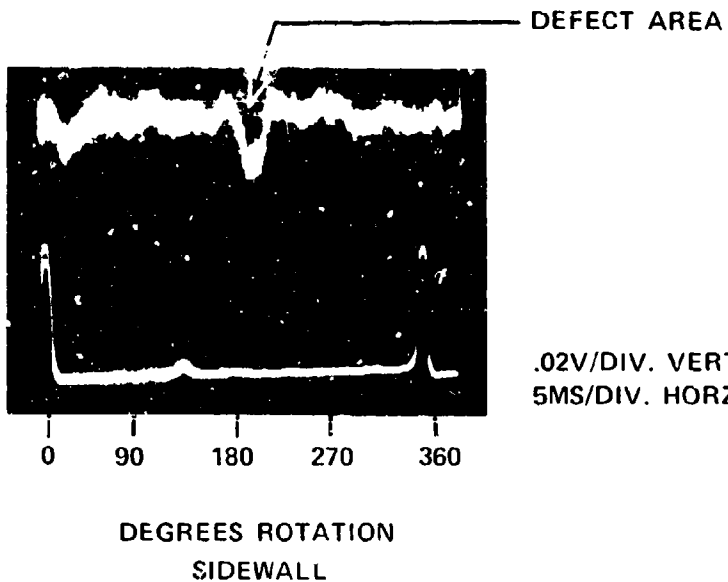
FIGURE 21

| 21 | CIRCUMFERENTIAL TEMPERATURE PROFILE OF TREAD AND LEFT SIDEWALL. TEST TIRE NO 5 WITH BUILT-IN DEFECT. ** |

CIRCUMFENTIAL TEMPERATURE
PROFILE, TEST TIRE NO. 5

TEST
CONDITIONS
50 MPH
1000# LOAD
32 PSI
CEMENT
ROAD=108F
AIR=74F

.05V/DIV. VERT.
5MS/DIV. HORZ.

.02V/DIV. VERT.
5MS/DIV. HORZ.

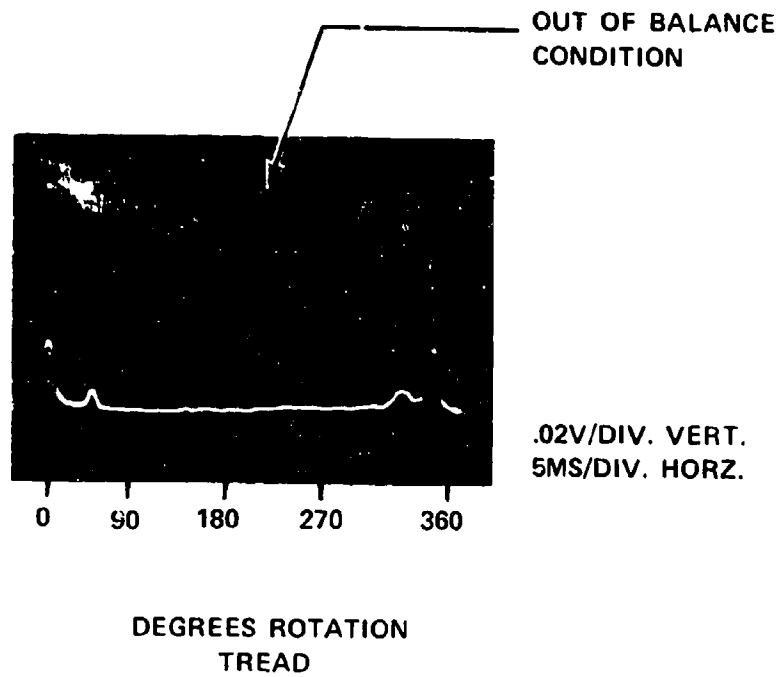
FIGURE 22

CIRCUMFERENTIAL TEMPERATURE
PROFILE OF OUT OF BALANCE
CONDITION, TEST TIRE NO. 1
